Project Name: Gold King Mine	Site Location: Silverton, San Juan County, Colorado	Project No. 0001/1408-01
--	---	------------------------------------

PHOTOGRAPH LOG

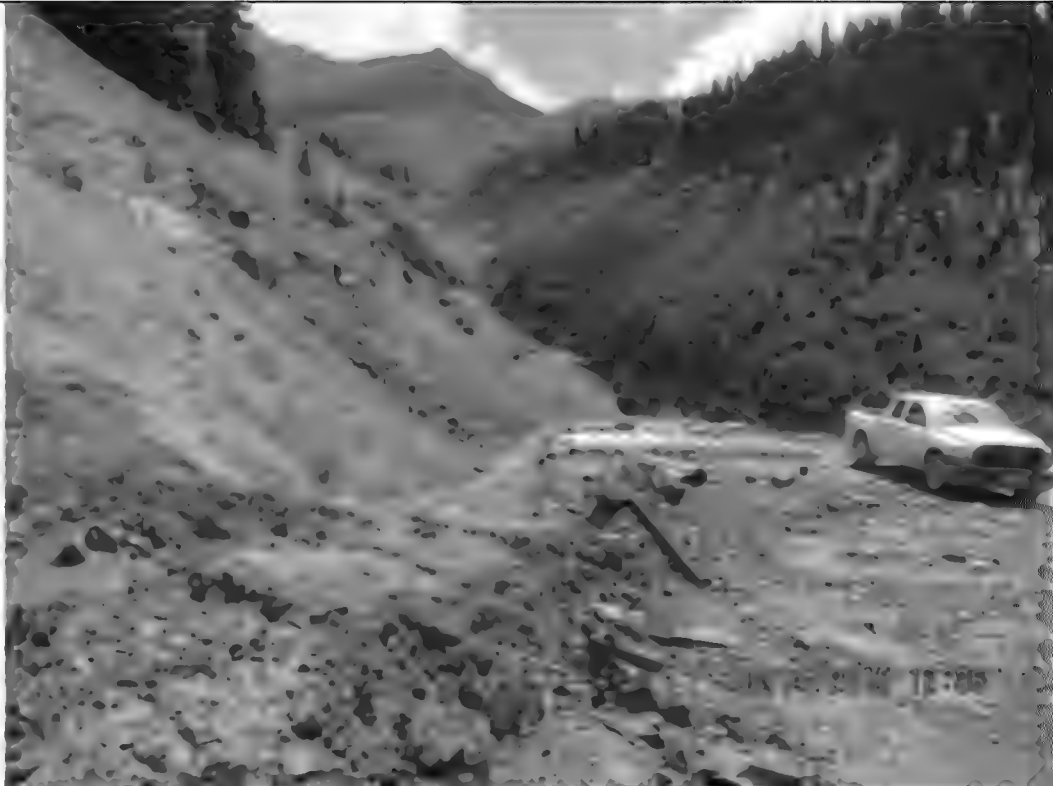
Photo No. 33	Date: 08/05/2015

Direction Photo Taken: East		
Description: Redirected flow into existing half culvert channel.

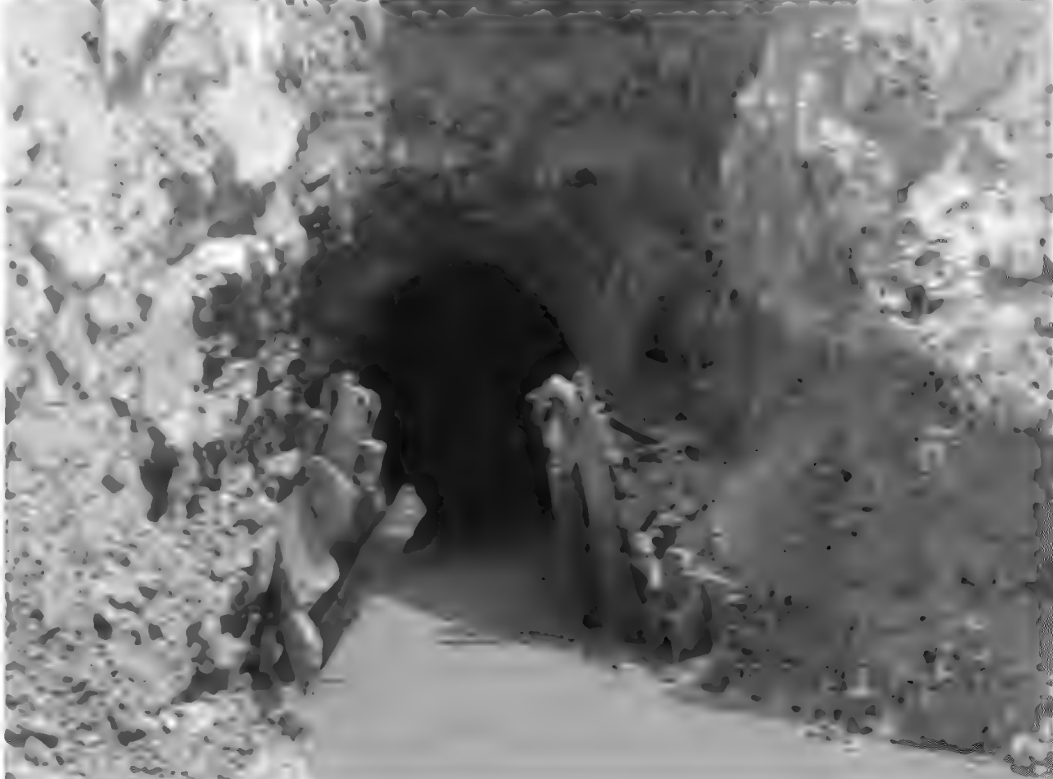
Photo No. 34	Date: 08/05/2015

Direction Photo Taken: North		
Description: Closeup of adit.

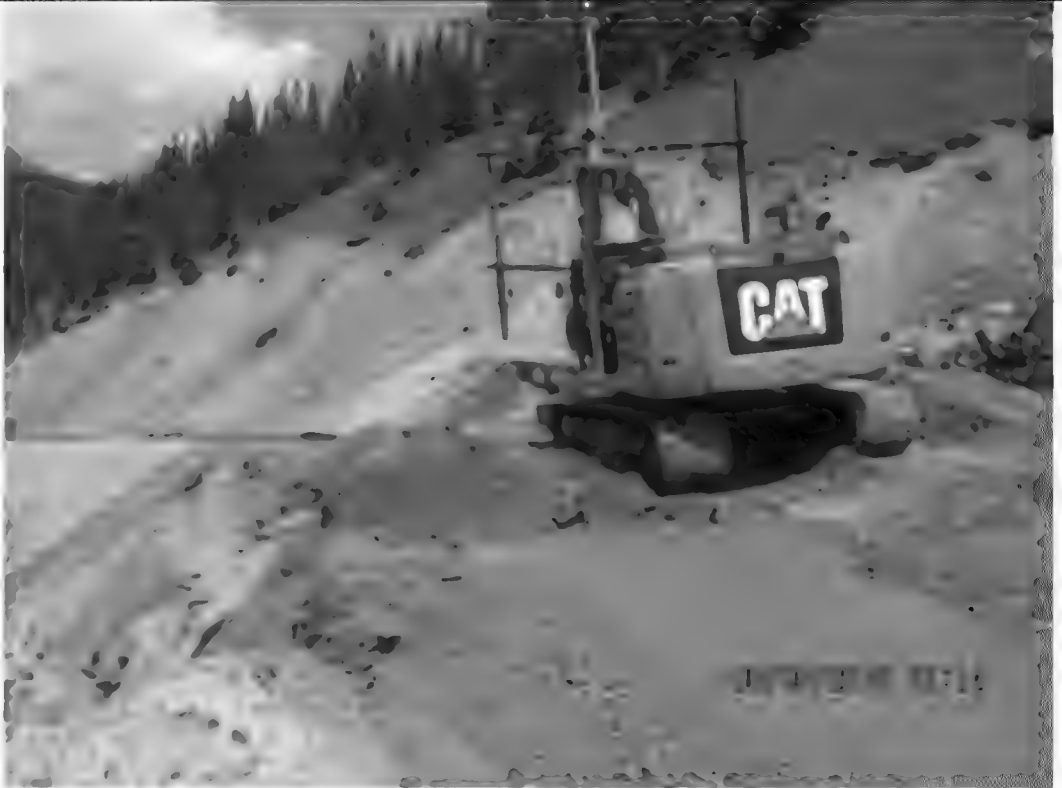
Photo No 35	Date: 08/05/2015

Direction Photo Taken: West		
Description: Excavator beginning work to secure safe exit route for equipment, vehicles, and personnel.		
Photo No 36	Date: 08/05/2015

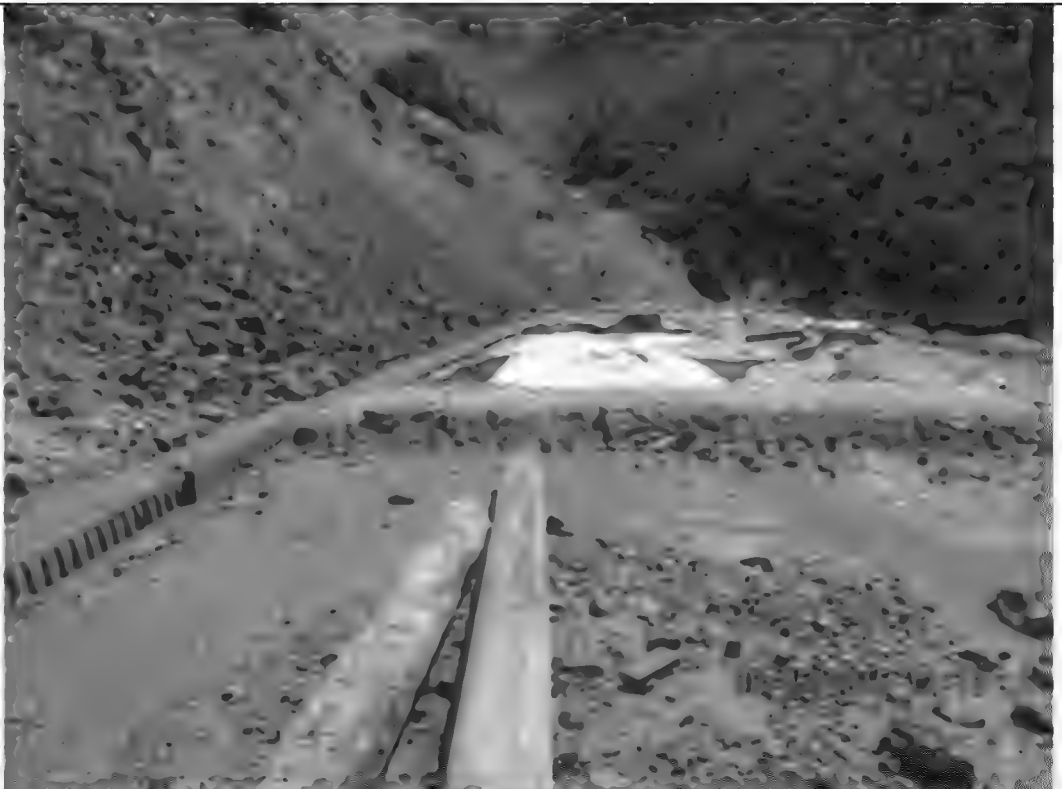
Direction Photo Taken: East		
Description: Existing flow channel at maximum capacity.

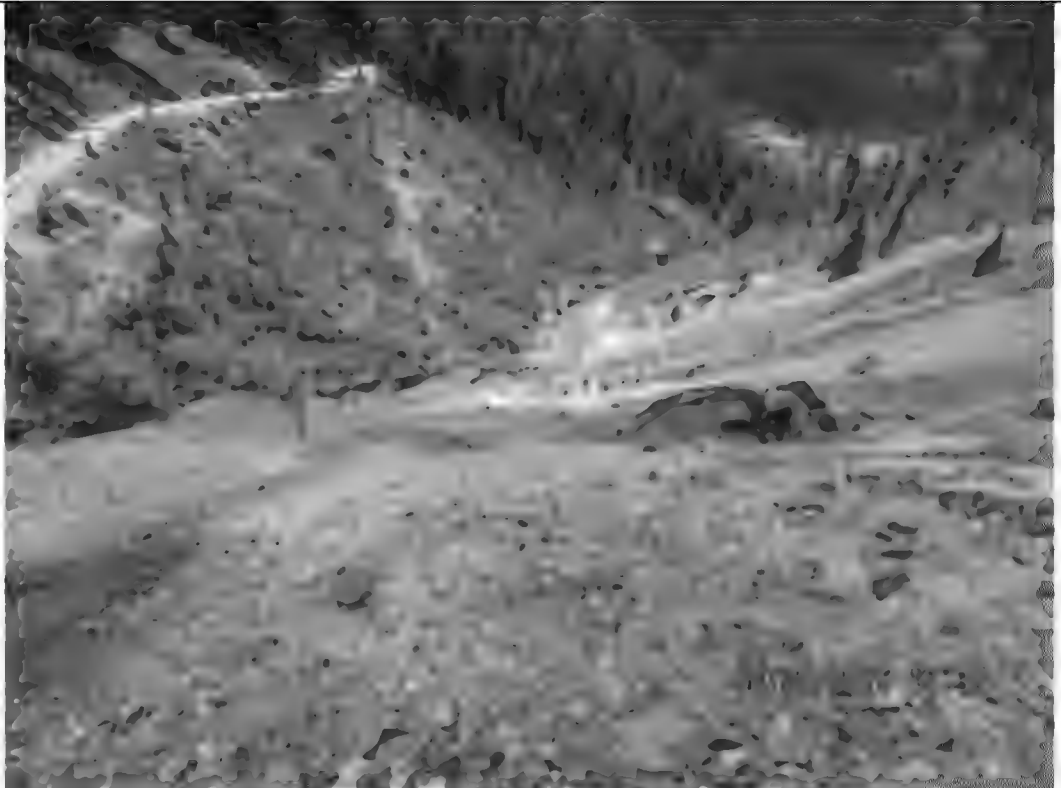
Photo No. 37	Date: 08/05/2015

Direction Photo Taken: Southwest/Down		
Description: Excavator progress on fixing access road to create a safe exit route

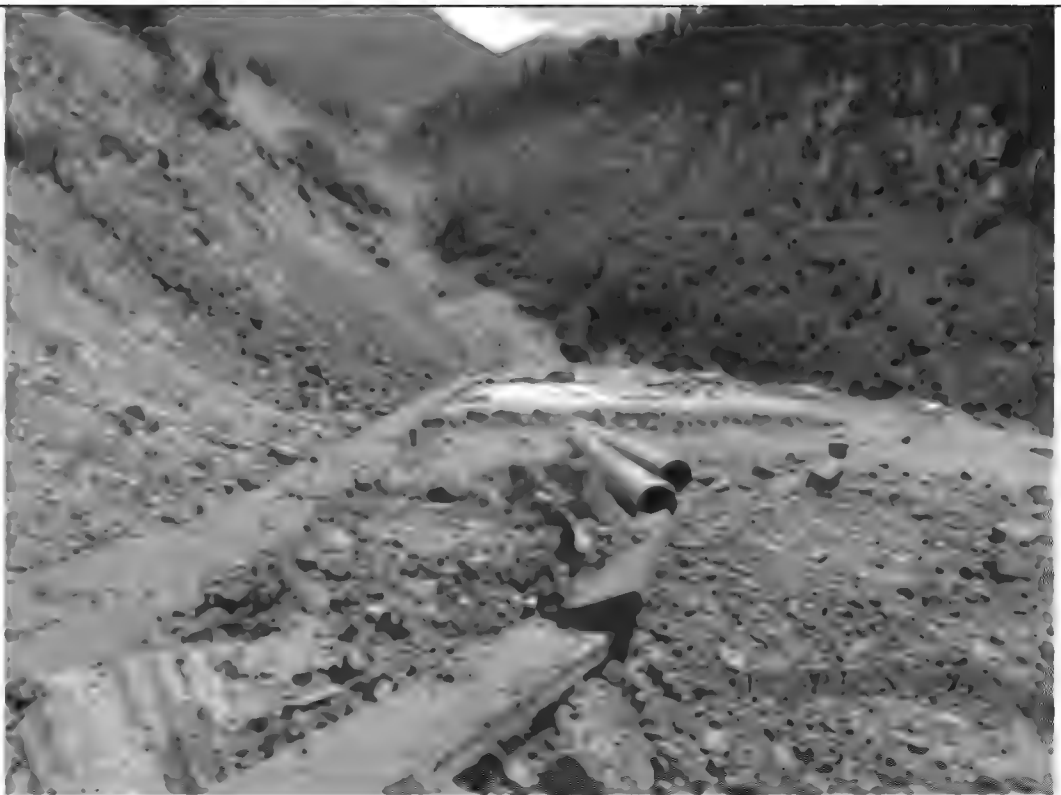
Photo No. 38	Date: 08/05/2015

Direction Photo Taken: East		
Description: Existing culvert flows subsiding minimally.

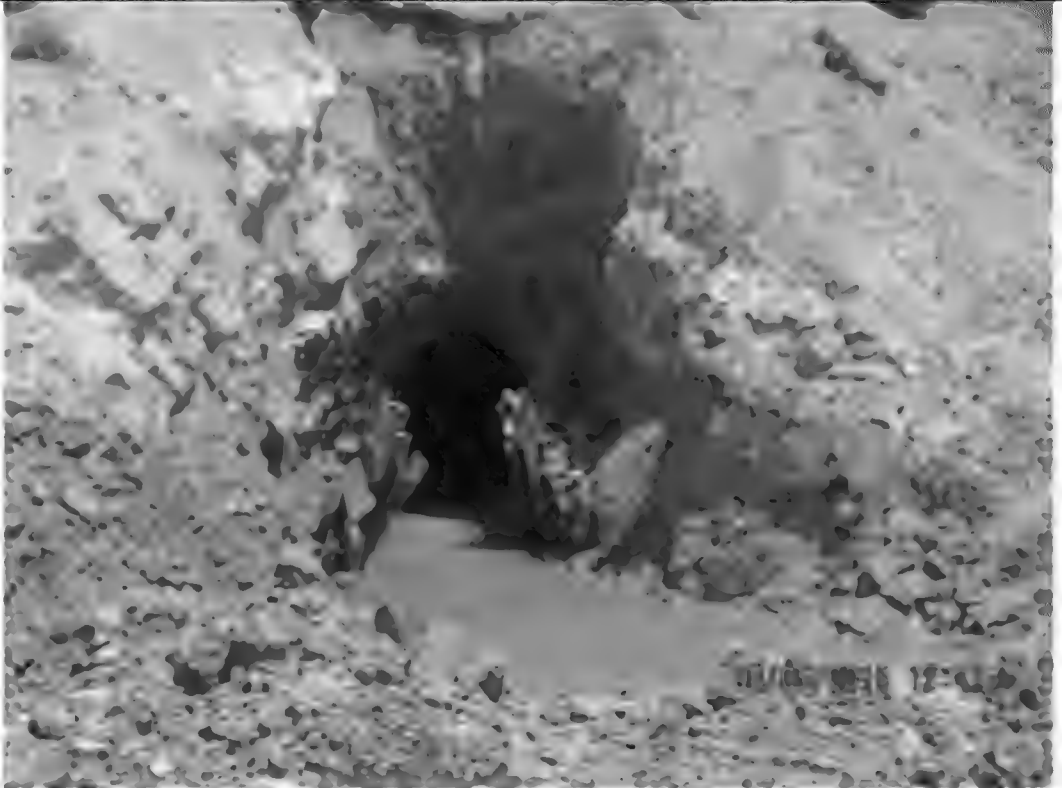
Photo No. 39	Date: 08/05/2015

Direction Photo Taken: North		
Description: No changes visible in adit structure or supports. Sloughing of materials inside the mine can be heard.		
Photo No. 40	Date: 08/05/2015

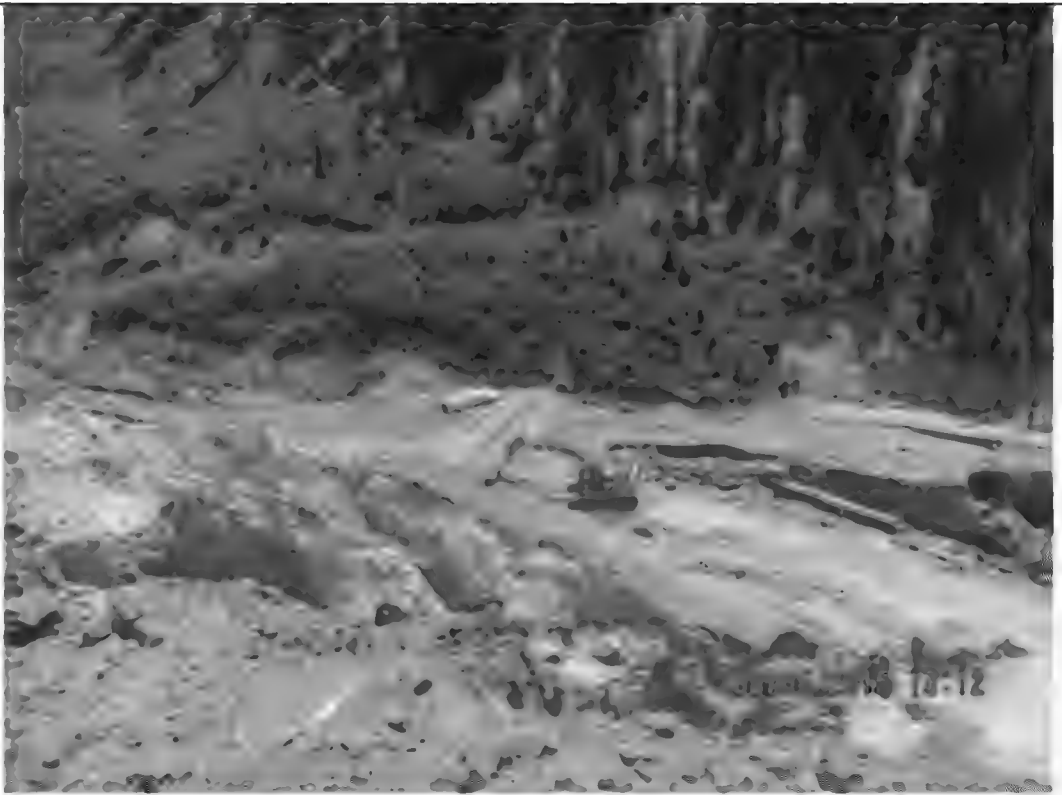
Direction Photo Taken: South/Down		
Description: Excavator progresses to washed out North Fork crossing.

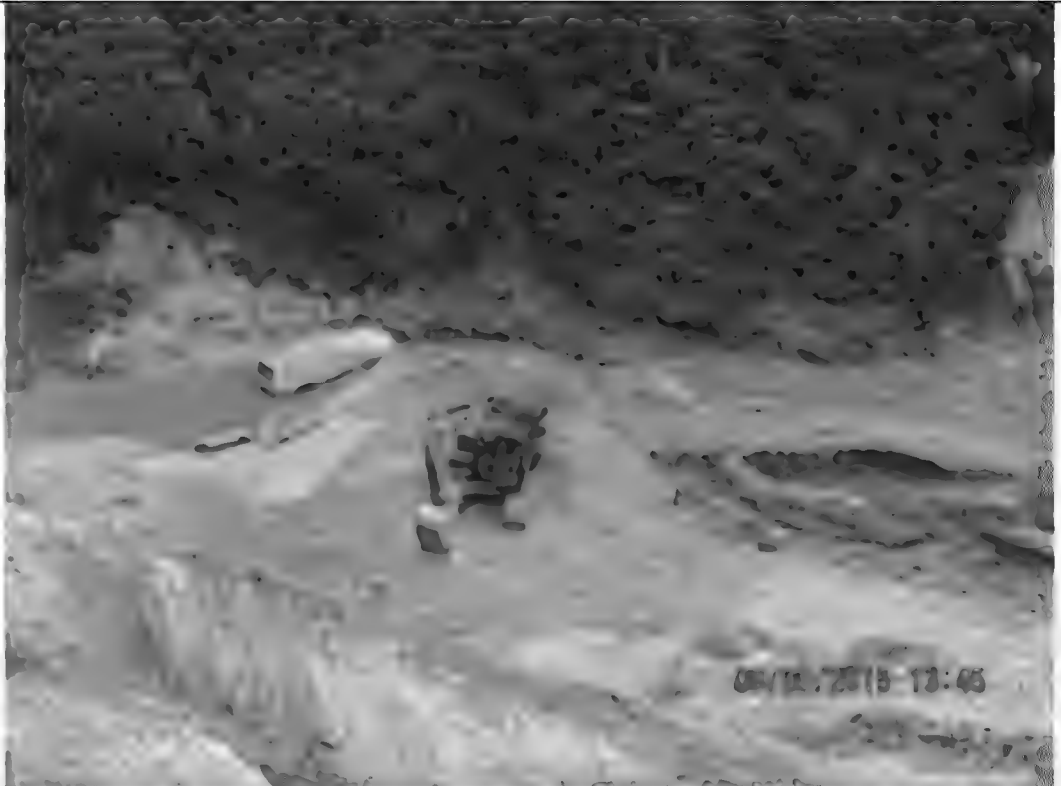
Photo No. 43	Date: 08/05/2015

Direction Photo Taken: South/Down		
Description: Excavator continues to fix access road. Continued high flow is slowing progress.

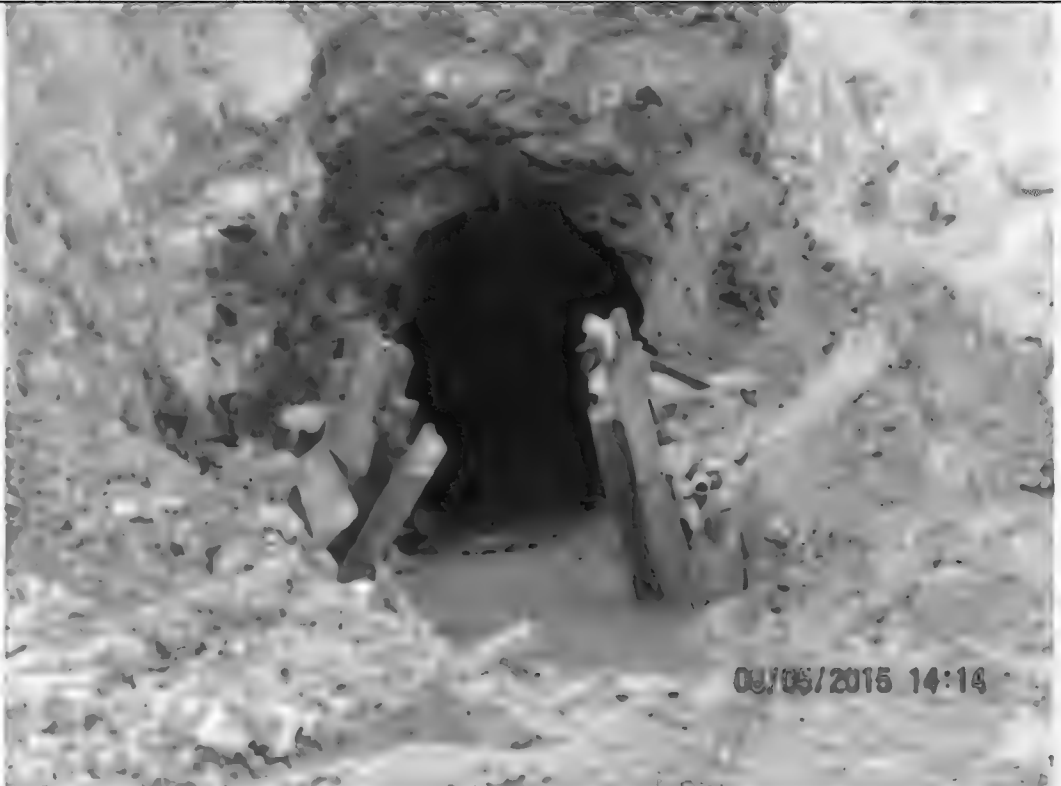
Photo No. 45	Date: 08/05/2015

Direction Photo Taken: North		
Description: Water levels lowering at adit entrance, no visible changes to structure.

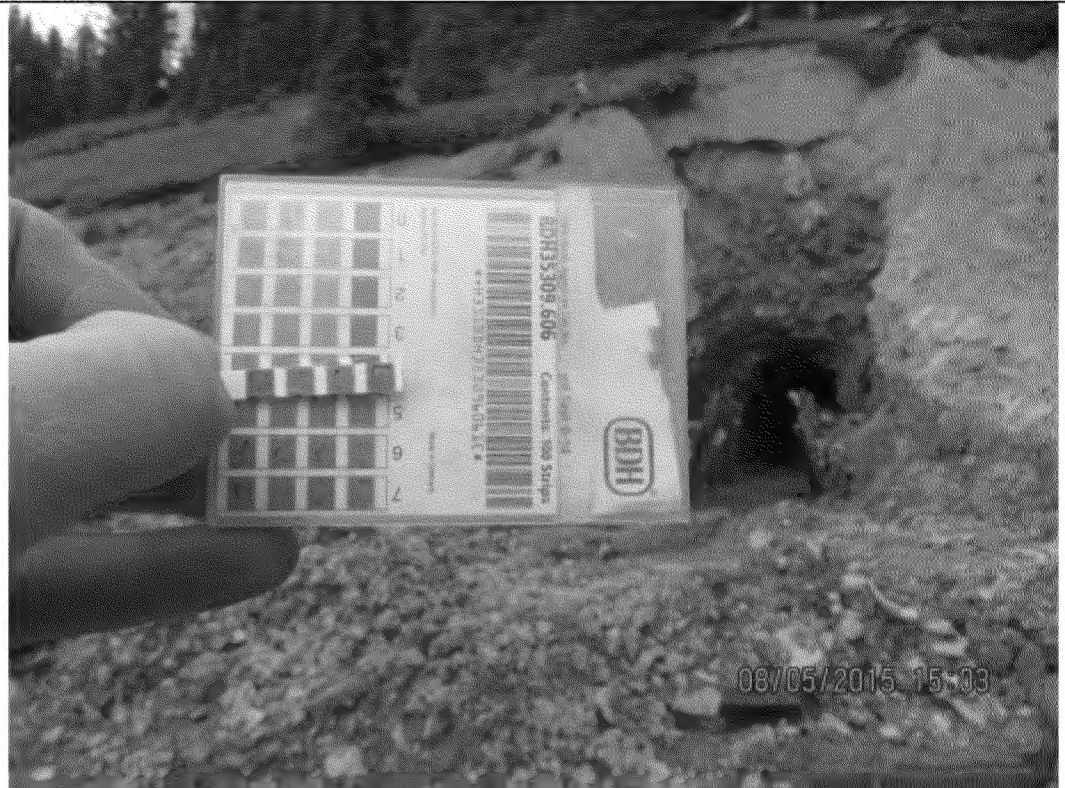
Photo No.
49

pH measured at approximately 4.5.

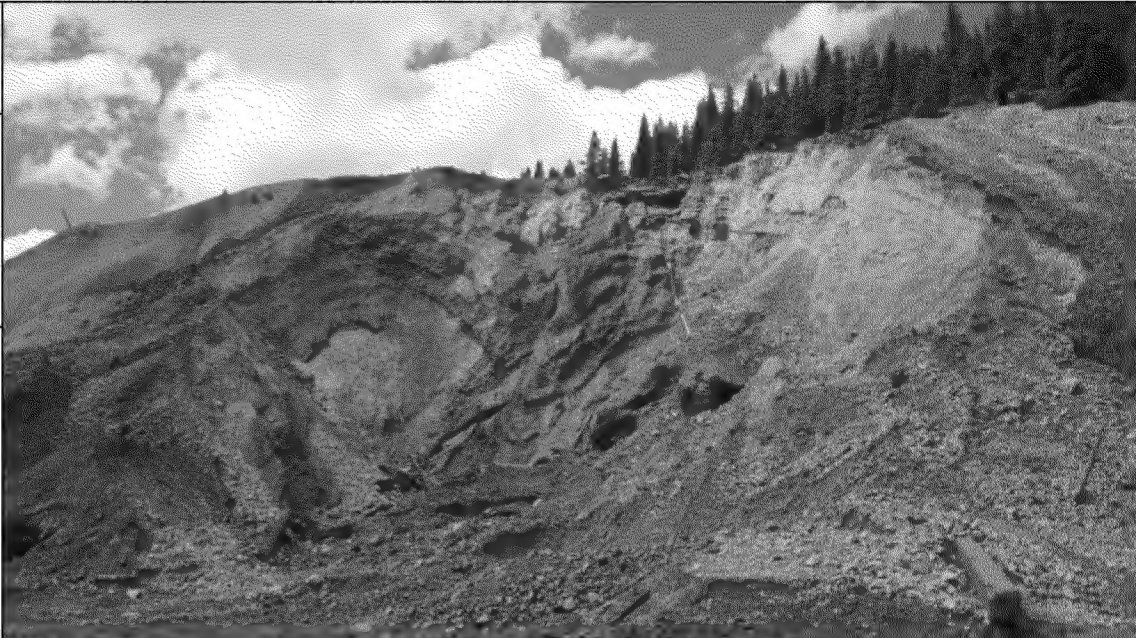
Photo No. 51	Date: 08/05/2015

Direction Photo Taken: North		
Description: Looking up from the toe of the Gold King waste dump directly south of the adit.

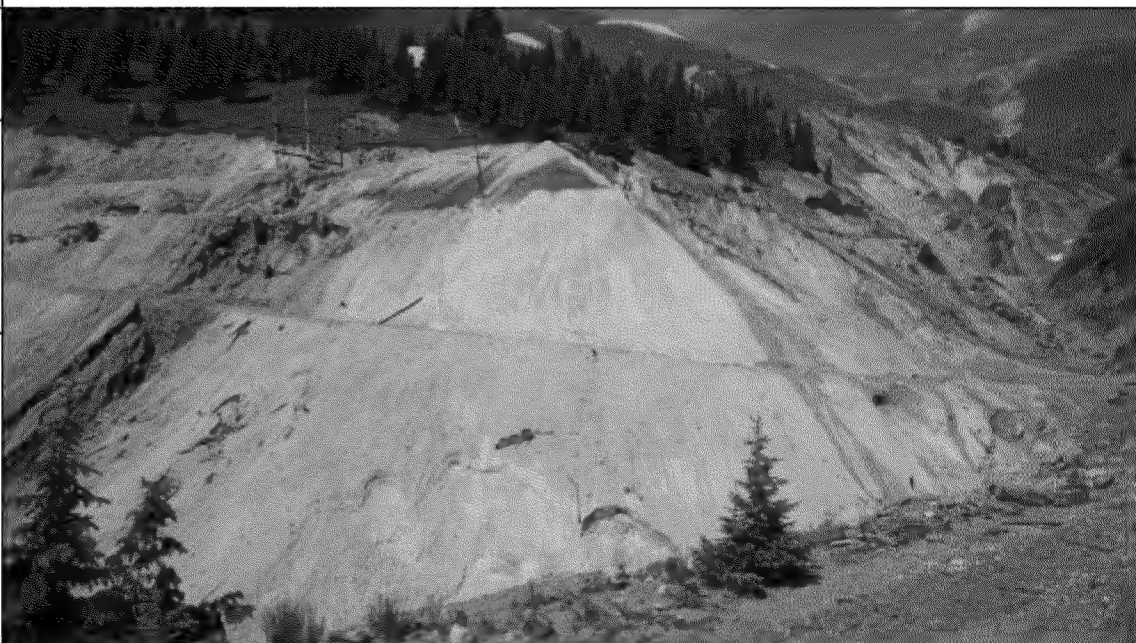
Photo No. 52	Date: 08/05/2015

Direction Photo Taken: Northeast		
Description: Gold King Mine tailings dump after water discharge.
